SCOOPING WATER IN THE AGE OF STEAM

When a thirsty locomotive took a drink at high speed, the results could be spectacular

BY JAMES ALEXANDER JR.

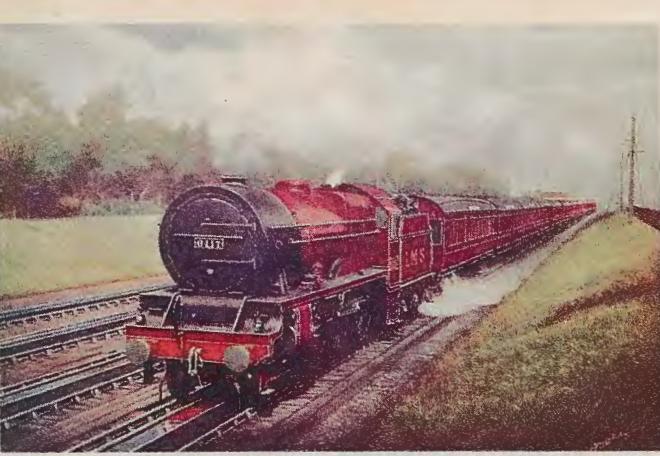
Led by 4-6-0 *Welsh Guardsman*, a London Midland & Scottish train (above) scoops water at the Whitmore troughs. Water overflows as a New York Central express train (opposite page) pulled by a Hudson uses the track pan at Rome, N.Y., in a September 1951 photo by S.K. Bolton Jr. of the Rail Photo Service.

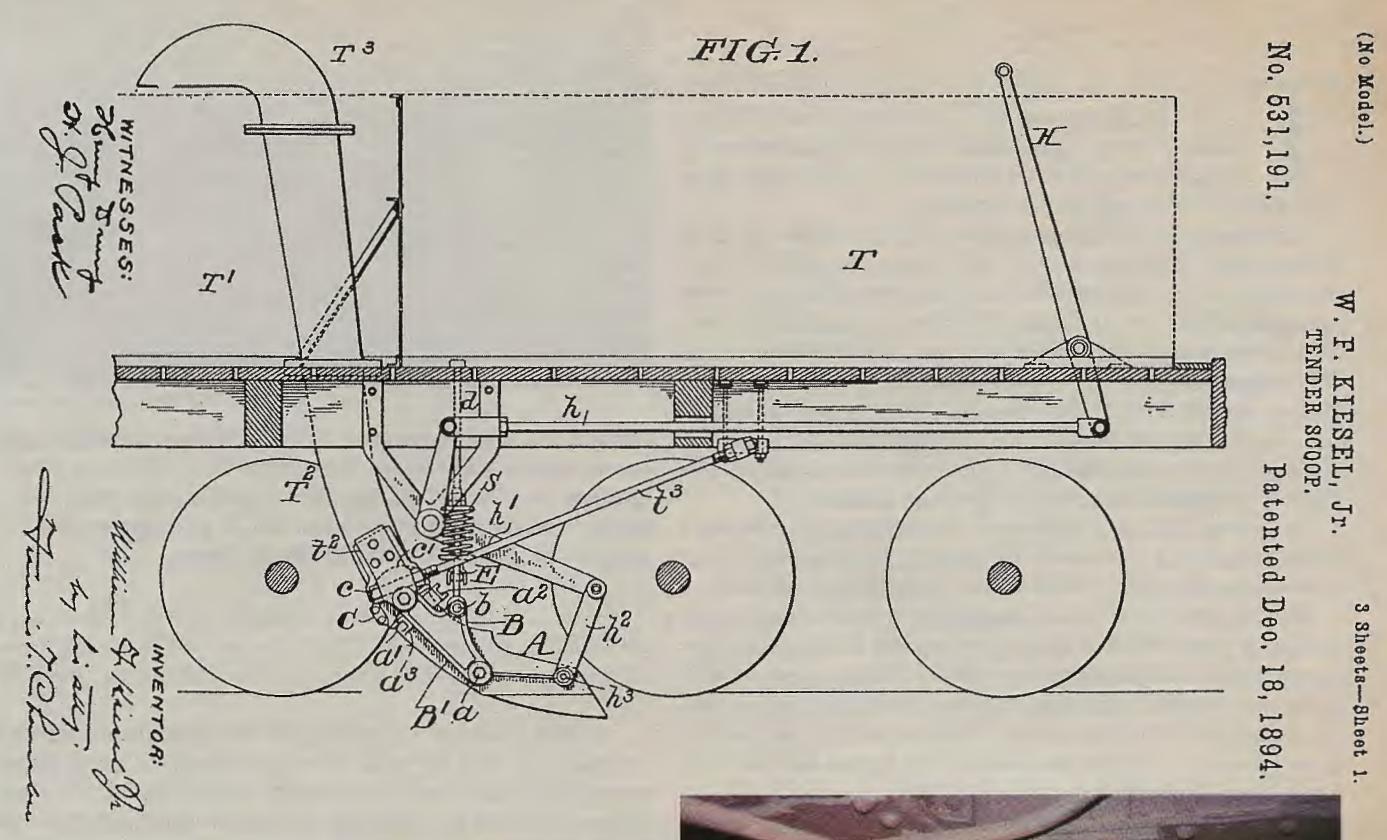
William F. Kiesel's patented scoop of 1894 (above) changed very little over the decades. A similar scoop can be seen under the tender of PRR E6s No. 460 (right) at the Strasburg museum.

Gladys by then had become Mrs. William F. Kiesel III. Early in his career, her father-in-law had studied the problems encountered by water scoops. In 1894, he patented a new scoop design which balanced the force of the water entering the scoop against the water exiting the scoop into the tank. This innovation doubled efficiency, with 3.3 gallons picked up per linear foot of trough in an early test at 70 mph.

Kiesel's original patent had the fireman pull a long rod in the front of the tender to lower and raise the scoop. This rod was known to kick back, sometimes causing bodily harm. Later, air cylinders operated the scoop, which improved efficiency and safety. Kiesel's pioneering work established basic industry standards. Scoops could be found on passenger and freight tenders alike, including PRR Atlantic, Pacific, Mikado, and Mountain types, as well as NYC Mohawks and Hudsons, among others.

Of five scoop-equipped PRR tenders preserved today at the Railroad Museum of Pennsylvania in Strasburg, the most easily viewed scoop is that installed on the Class E6s Atlantic No. 460, built in 1914. Popularly known as the "Lindbergh Engine," its water-scooping ability played a major role in its famous race against an airplane in 1927 to deliver to New York City films of Charles Lindbergh's triumphant welcome in Washington after his solo flight across the Atlantic.

The overall length of the E6 tender's scooping mechanism is about 4 feet. The dipper is 13 inches wide, 8½ inches high, and about 20 inches from its front edge to its pivot point. Retracted, it is about 4 inches above the rail. Scoops on other PRR tenders followed the basic Kiesel design, with the air cylinder up behind the coal bunker or elsewhere down under.

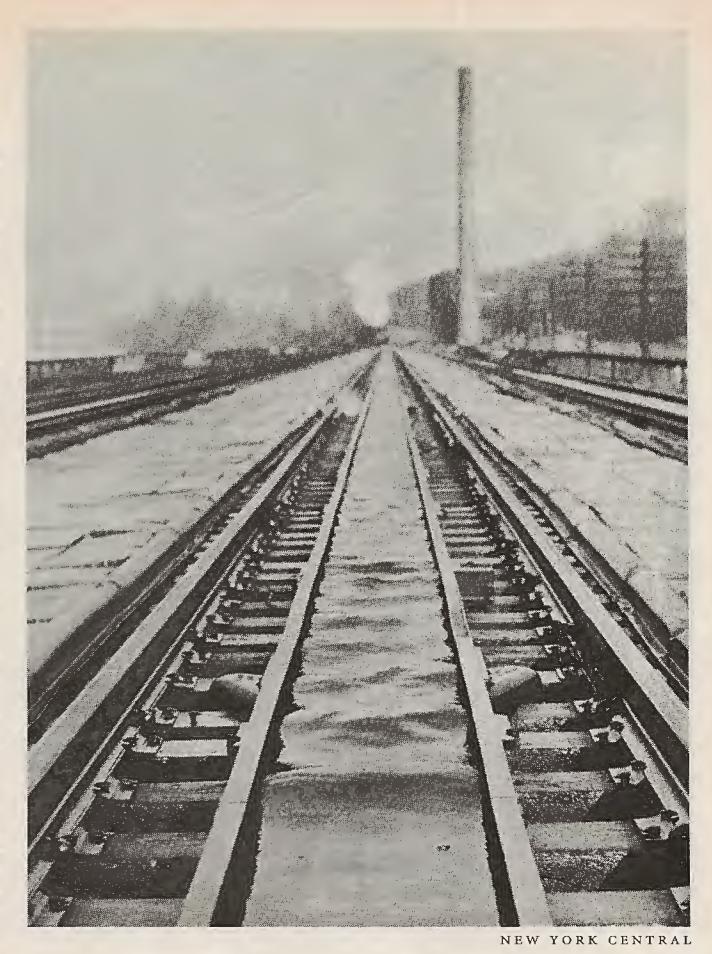
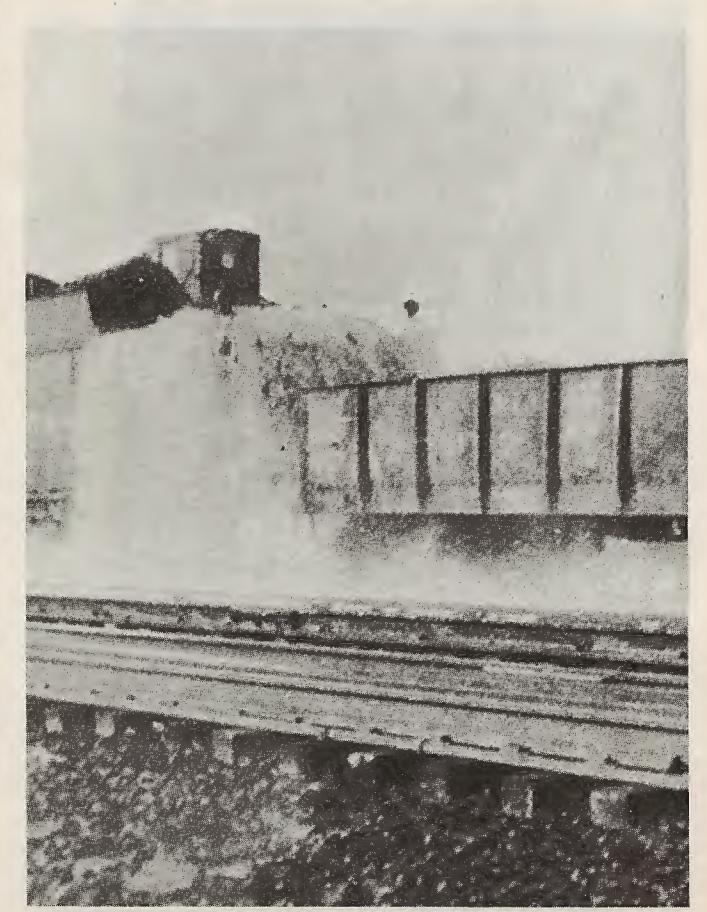
Curbing protects thawing pipes at a typical NYC track pan near New Hamburg, N.Y. (top). Water cascades from the rear of a PRR tender (right) at the Wilmore (Pa.) track pans in the late 1940's.

Pan areas were constantly wet, slippery, and covered with moss and debris. Steady leakage or splashing of water could undermine the trackbed, and Belgian blocks and similar paving materials were typically installed to protect the understructure and guide the water to drains which were installed throughout the pan area. Tunnels of up to 4 feet in diameter crossed under the trackbed at intervals, to collect the water and provide access for the water supply and steam piping. In some cases the captured water was reused. Periodic cleaning out of these tunnels was difficult and messy.

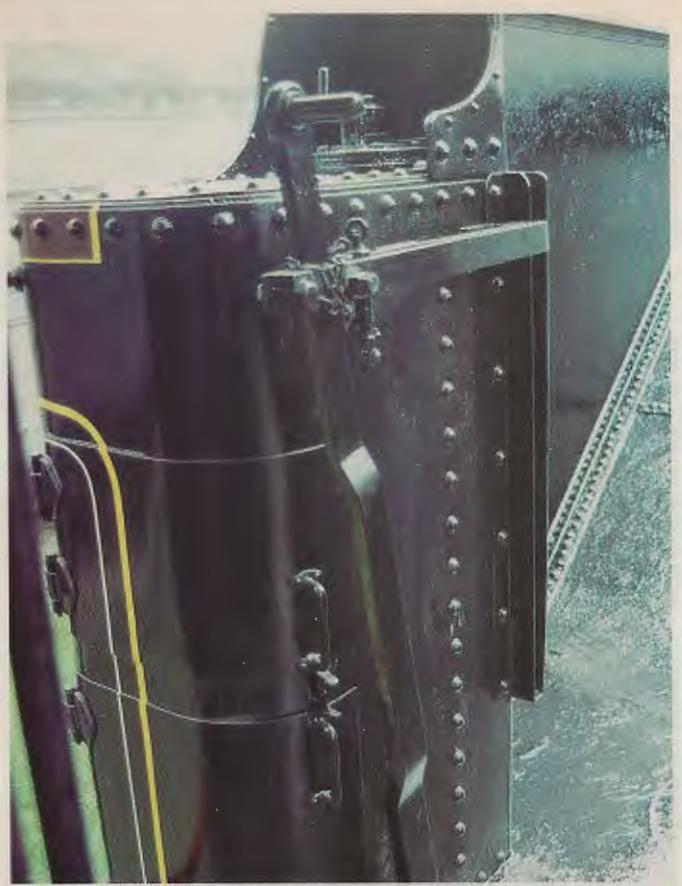
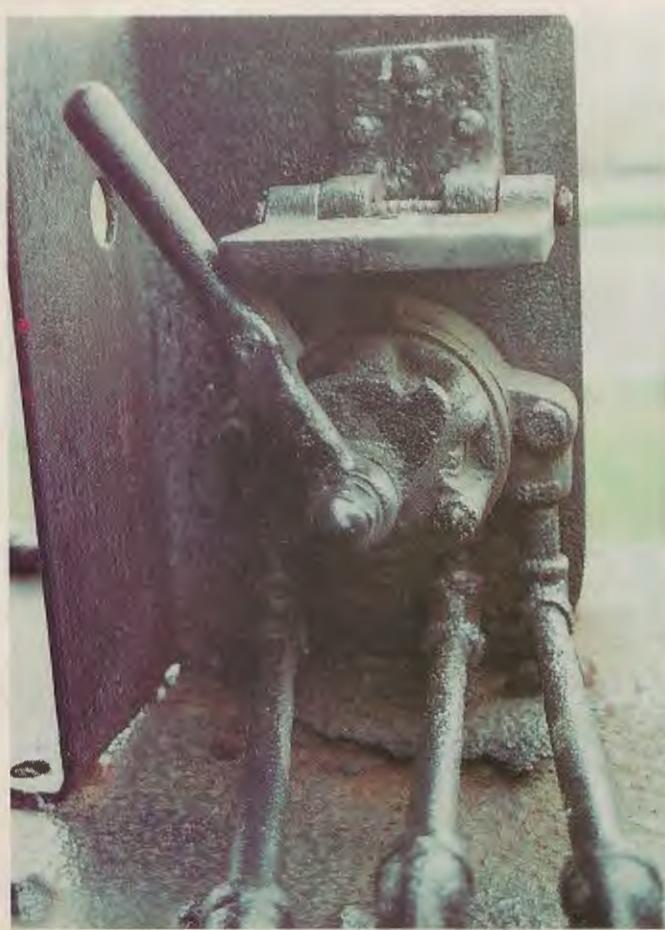
Manual levers such as the one on PRR 7002 at Strasburg (left) were difficult to operate and could snap against an unwary hand. On the engineer's side of PRR No. 460's cab, the air-operated valve handle for the scoop (below, left) is in the left, or raised, position.

from which it would descend again if not properly secured. Especially in the earlier days before air-operated controls, firemen sometimes let the ramp push the scoop back up, rather than risk a broken bone from the control rod bucking back on them.

The scoop control on the PRR tenders featured a single valve, with a lock to prevent it from being moved accidentally. The NYC control mechanism involved a control operated by the fireman on the left side of the tender, and two cut-out cocks, one operated by the fireman, the other by the engineer.

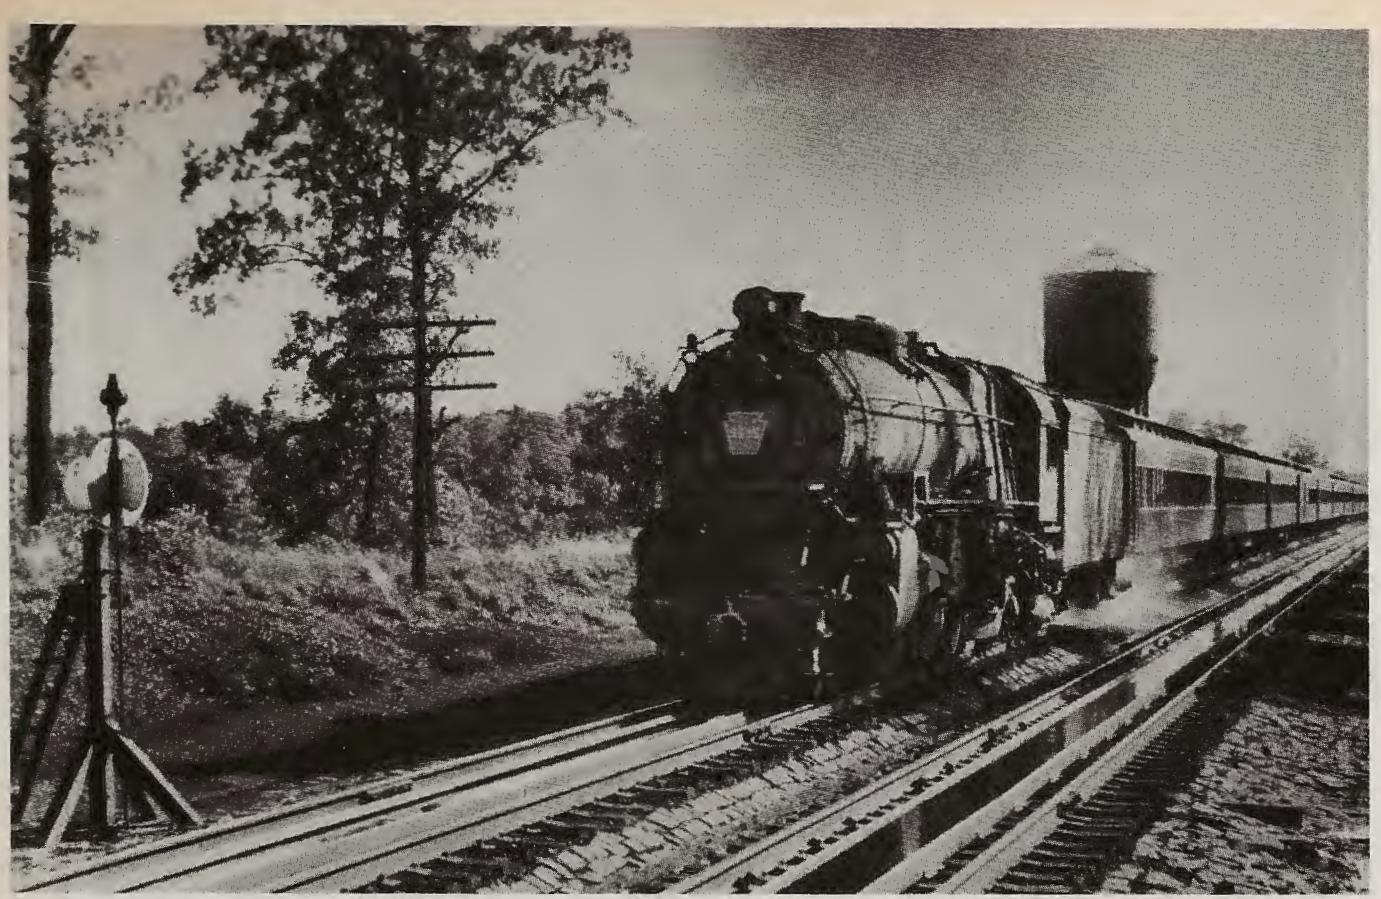
At Ancora, N.J., on the PRSL, a K4 approaches the "lift-scoop" signal at the end of the pan. Ladder is for oil-lamp maintenance.

"Track troughs in service will be marked: At entrance—By day: White target. —By night: Lunar white light. At exit—By day: Yellow target. —By night: Yellow light. At middle —Same as at entrance. Out of service—By day and night, all yellow targets and yellow lights.
